Servicing of Cold Water Extraction Pump

Customer: Collinsville Power Station

Case Study ID: CS-91

Date: November 2012

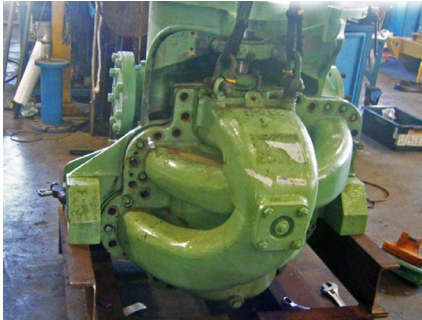
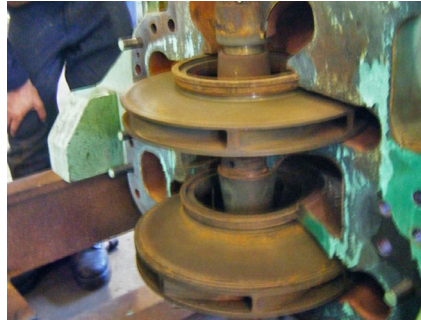
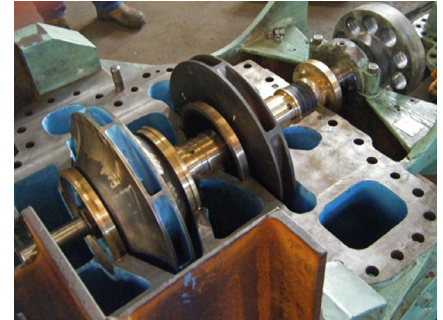
- The pump's wear rings were worn unevenly, indicating shaft run out
- Shaft centre supports and lower support bushes were worn beyond safe tolerance
- Gasket material was missing between the 1st and 2nd stage, revealing the pump housing had spread slightly in the centre

- After the casing and cover survey was completed it was confirmed there was up to 0.028" hollow in the casing and 0.026" hollow in the cover – with an average 0.010"
- Impellers worn on ring landings and required machining to suit new wear rings
- The pump shaft had run out on the lower journal
- A foreign object was found in 1st stage impeller (plastic drink bottle)
- The 2nd stage impeller hub was severely damaged.

- Impellers were machined, and new wear rings were made
- Damage hub was machined and fitted to 2nd stage impeller
- Pump casings were machined flat
- Wear ring and bush landings were 'horizontal bored'
- The entire internals of the pump were painted with a ceramic coating
- Impellers were balanced
- All bearings and shaft bushes were replaced
- The pump was pressure tested
- The pump was painted and detailed
